HOME
report

SINGLE SURVEY
ENERGY REPORT
PROPERTY QUESTIONNAIRE
VALUATION REPORT

Property Address	3 Roseisle Maltings Bungalows Roseisle Elgin IV30 5YP
Customer	Mrs M Younie
Date of Inspection	17/03/2025
Prepared by	India Georgeson Harvey Donaldson & Gibson Chartered Surveyors

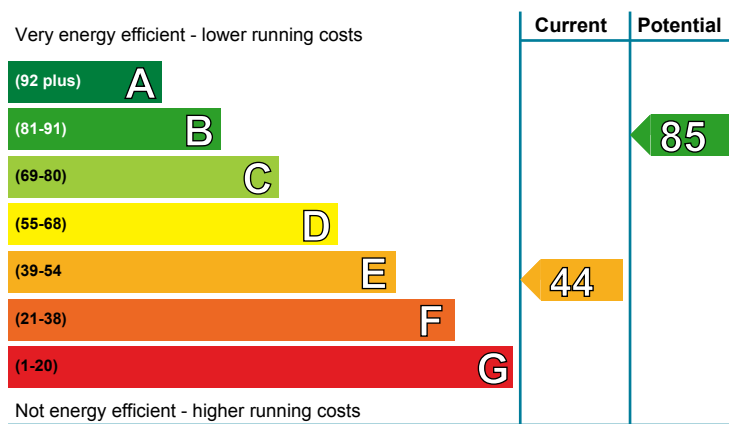
Energy Efficiency Rating

This graph shows the current efficiency of your home, taking into account both energy efficiency and fuel costs. The higher this rating, the lower your fuel bills are likely to be.

Your current rating is **band E (44)**. The average rating for EPCs in Scotland is **band D (61)**.

The potential rating shows the effect of undertaking all of the improvement measures listed within your recommendations report.

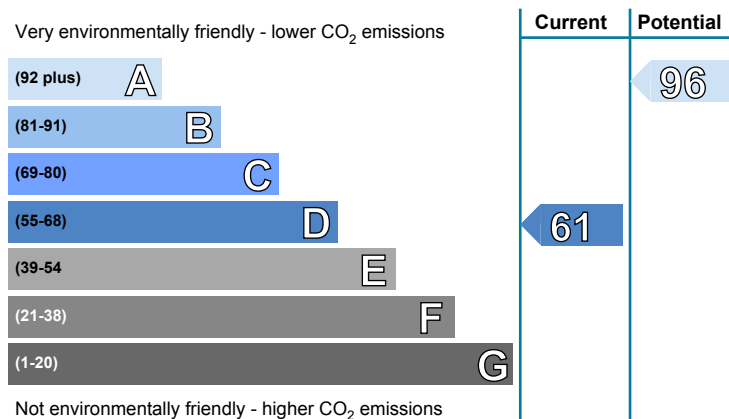
Environmental Impact (CO₂) Rating

This graph shows the effect of your home on the environment in terms of carbon dioxide (CO₂) emissions. The higher the rating, the less impact it has on the environment.
