HOME
report

SINGLE SURVEY
ENERGY REPORT
PROPERTY QUESTIONNAIRE
VALUATION REPORT

Property Address	Sunnymeade Alexandra Terrace Forres IV36 1DL
Customer	Mr K Sutherland
Date of Inspection	09/05/2024
Prepared by	Douglas J H Mowat Harvey Donaldson & Gibson Chartered Surveyors

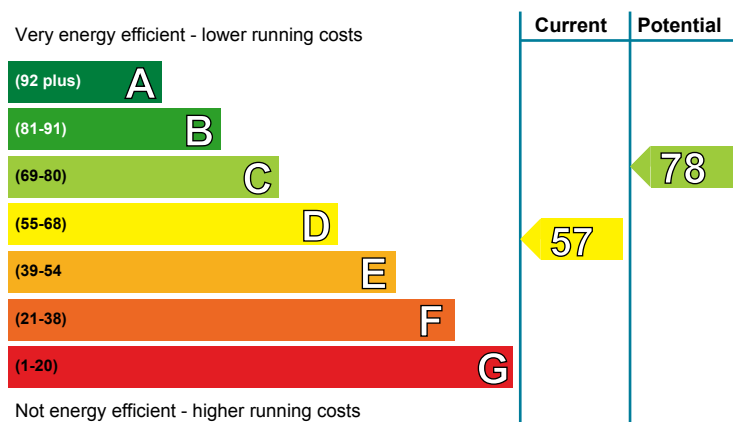
Energy Efficiency Rating

This graph shows the current efficiency of your home, taking into account both energy efficiency and fuel costs. The higher this rating, the lower your fuel bills are likely to be.

Your current rating is **band D (57)**. The average rating for EPCs in Scotland is **band D (61)**.

The potential rating shows the effect of undertaking all of the improvement measures listed within your recommendations report.

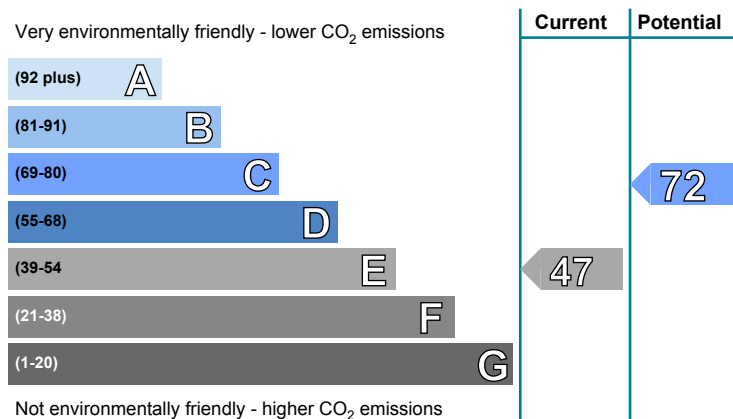
Environmental Impact (CO₂) Rating

This graph shows the effect of your home on the environment in terms of carbon dioxide (CO₂) emissions. The higher the rating, the less impact it has on the environment.
