HOME
report

SINGLE SURVEY
ENERGY REPORT
PROPERTY QUESTIONNAIRE
VALUATION REPORT

Survey report on:

Property Address	14 Brander Street Burghead Elgin IV30 5XD
Customer	Mr & Mrs M Duncanson
Date of Inspection	21/12/2023
Prepared by	Douglas J H Mowat Harvey Donaldson & Gibson Chartered Surveyors

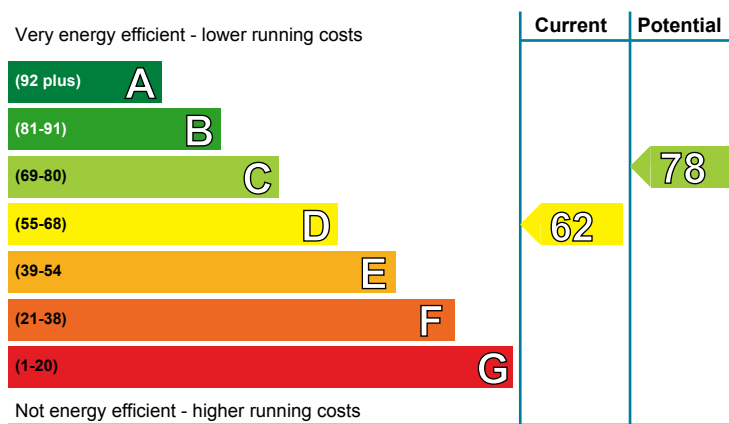
Energy Efficiency Rating

This graph shows the current efficiency of your home, taking into account both energy efficiency and fuel costs. The higher this rating, the lower your fuel bills are likely to be.

Your current rating is **band D (62)**. The average rating for EPCs in Scotland is **band D (61)**.

The potential rating shows the effect of undertaking all of the improvement measures listed within your recommendations report.

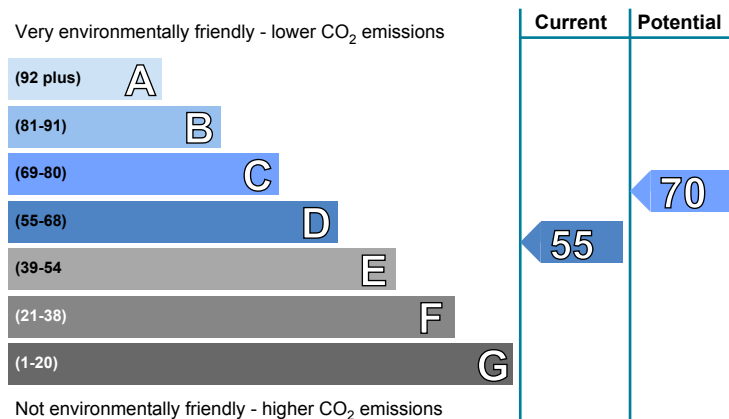
Environmental Impact (CO₂) Rating

This graph shows the effect of your home on the environment in terms of carbon dioxide (CO₂) emissions. The higher the rating, the less impact it has on the environment.
