SINGLE SURVEY  
ENERGY REPORT  
PROPERTY QUESTIONNAIRE  
VALUATION REPORT

# Single Survey

<b>Property Address</b>	Towieburn Keith AB55 5JA
<b>Customer</b>	Mr A Hemington & Ms C Healey
<b>Date of Inspection</b>	30/04/2024
<b>Prepared by</b>	Kyle Mutch Harvey Donaldson & Gibson Chartered Surveyors

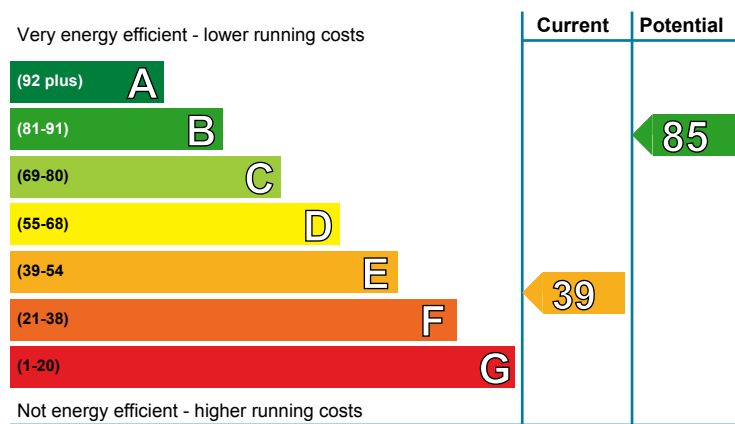
## Energy Efficiency Rating

This graph shows the current efficiency of your home, taking into account both energy efficiency and fuel costs. The higher this rating, the lower your fuel bills are likely to be.

Your current rating is **band E (39)**. The average rating for EPCs in Scotland is **band D (61)**.

The potential rating shows the effect of undertaking all of the improvement measures listed within your recommendations report.

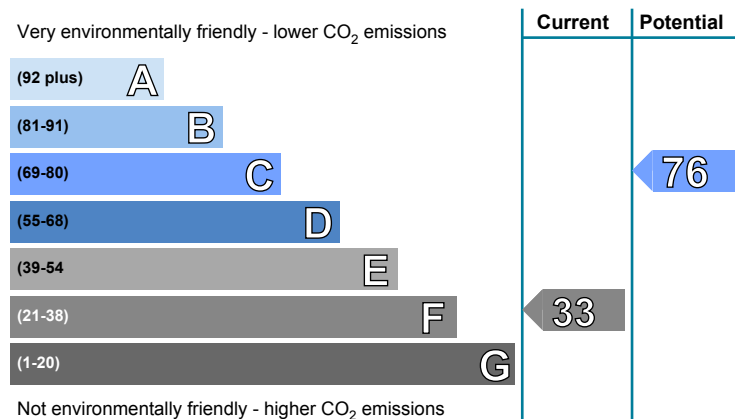
## Environmental Impact (CO<sub>2</sub>) Rating

This graph shows the effect of your home on the environment in terms of carbon dioxide (CO<sub>2</sub>) emissions. The higher the rating, the less impact it has on the environment.
