HOME
report

Single Survey

Property Address	43 Easter Road Kinloss Forres IV36 3FG
Customer	Ms P Nichols
Date of Inspection	31/01/2024
Prepared by	John I Dougan Harvey Donaldson & Gibson Chartered Surveyors

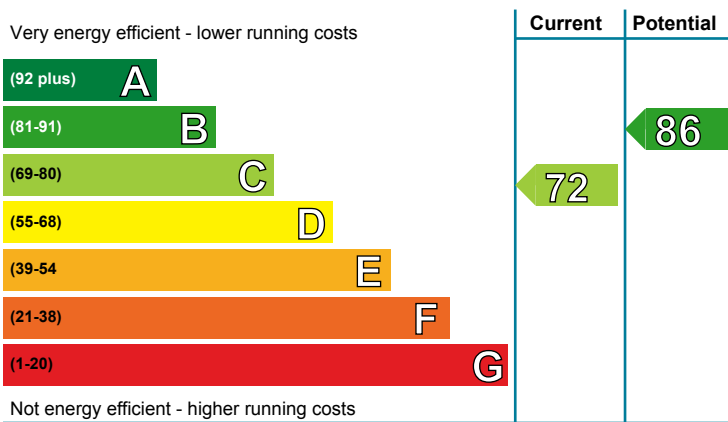
Energy Efficiency Rating

This graph shows the current efficiency of your home, taking into account both energy efficiency and fuel costs. The higher this rating, the lower your fuel bills are likely to be.

Your current rating is **band C (72)**. The average rating for EPCs in Scotland is **band D (61)**.

The potential rating shows the effect of undertaking all of the improvement measures listed within your recommendations report.
