HOME
report

SINGLE SURVEY
ENERGY REPORT
PROPERTY QUESTIONNAIRE
VALUATION REPORT

Survey report on:

Property Address	37 Grant Street Burghead Elgin IV30 5UE
Customer	Mr C O'Connor (POA) & Mr J O'Connor
Date of Inspection	09/05/2024
Prepared by	Paul Delaney Harvey Donaldson & Gibson Chartered Surveyors

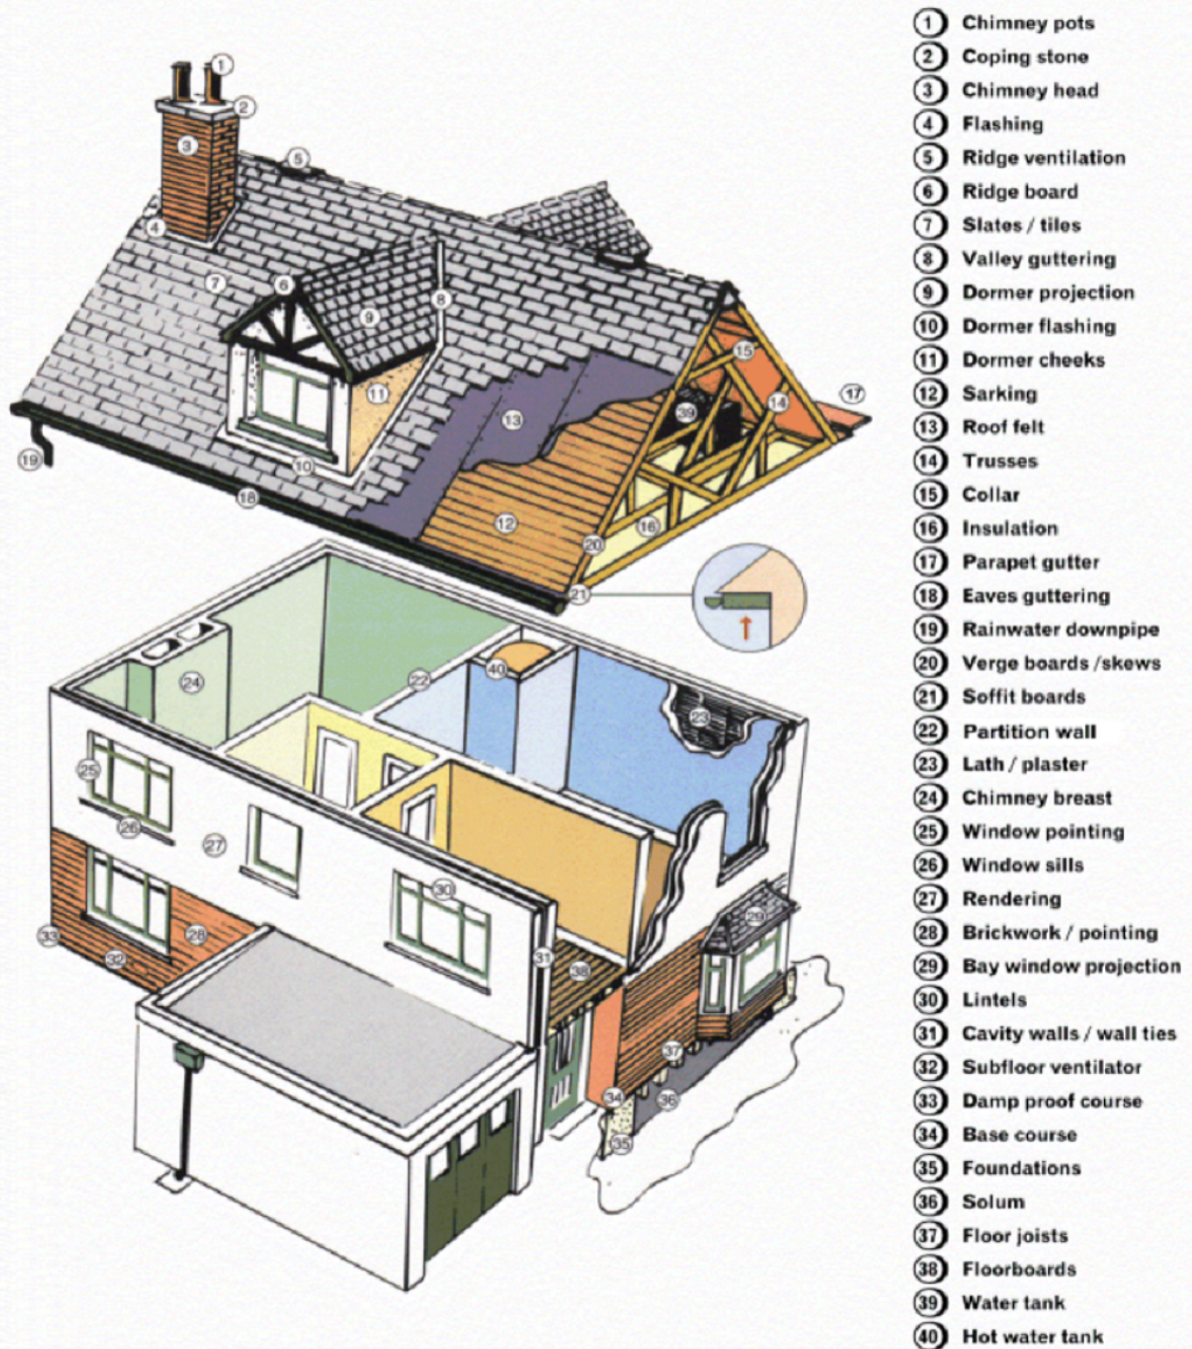
Sectional Diagram showing elements of a typical house

Reference may be made in this report to some or all of the above component parts of the property. This diagram may assist you in locating and understanding these items.
