**HOME**  
report

SINGLE SURVEY  
ENERGY REPORT  
PROPERTY QUESTIONNAIRE  
VALUATION REPORT

# Single Survey

<b>Property Address</b>	10 Hawthorn Road Elgin IV30 1PG
<b>Customer</b>	Dr G Laing
<b>Date of Inspection</b>	27/01/2025
<b>Prepared by</b>	India Georgeson Harvey Donaldson & Gibson Chartered Surveyors

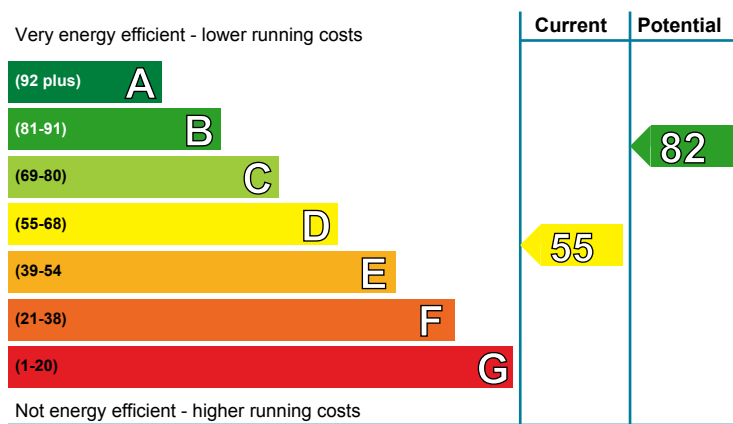
## Energy Efficiency Rating

This graph shows the current efficiency of your home, taking into account both energy efficiency and fuel costs. The higher this rating, the lower your fuel bills are likely to be.

Your current rating is **band D (55)**. The average rating for EPCs in Scotland is **band D (61)**.

The potential rating shows the effect of undertaking all of the improvement measures listed within your recommendations report.

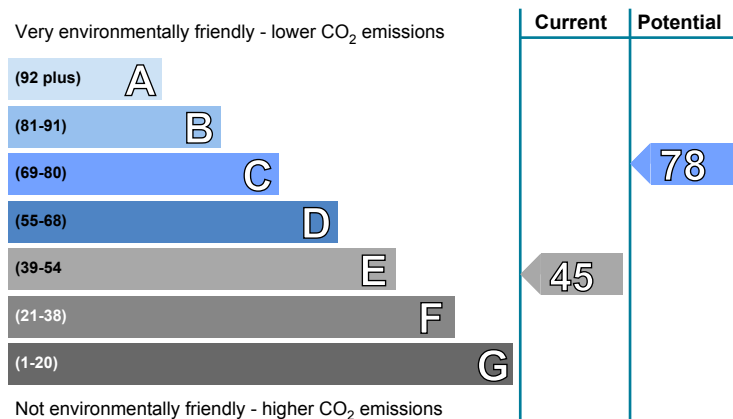
## Environmental Impact (CO<sub>2</sub>) Rating

This graph shows the effect of your home on the environment in terms of carbon dioxide (CO<sub>2</sub>) emissions. The higher the rating, the less impact it has on the environment.
