HOME
report

SINGLE SURVEY
ENERGY REPORT
PROPERTY QUESTIONNAIRE
VALUATION REPORT

Single Survey

Property Address	3 Logie Cottages Forres IV36 1EG
Customer	Mr T Flood
Date of Inspection	21/01/2025
Prepared by	India Hill Harvey Donaldson & Gibson Chartered Surveyors

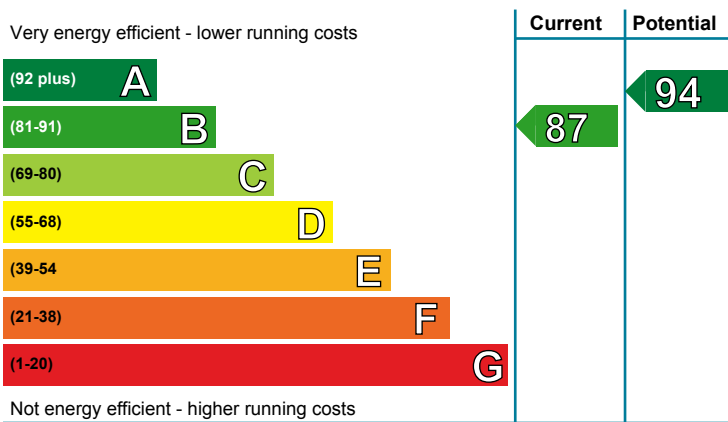
Energy Efficiency Rating

This graph shows the current efficiency of your home, taking into account both energy efficiency and fuel costs. The higher this rating, the lower your fuel bills are likely to be.

Your current rating is **band B (87)**. The average rating for EPCs in Scotland is **band D (61)**.

The potential rating shows the effect of undertaking all of the improvement measures listed within your recommendations report.

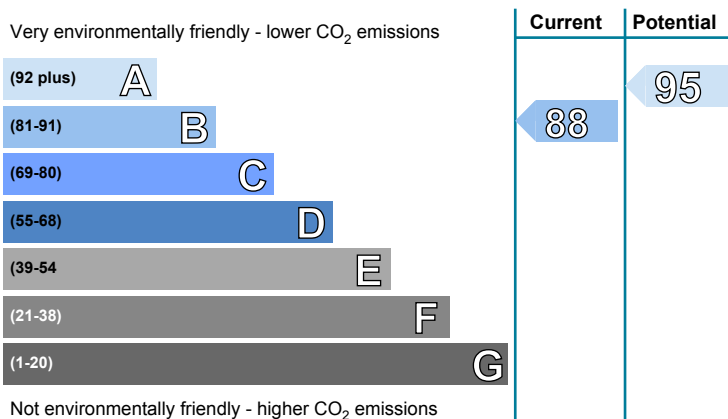
Environmental Impact (CO₂) Rating

This graph shows the effect of your home on the environment in terms of carbon dioxide (CO₂) emissions. The higher the rating, the less impact it has on the environment.
