HOME
report

SINGLE SURVEY
ENERGY REPORT
PROPERTY QUESTIONNAIRE
VALUATION REPORT

Survey report on:

Property Address	Slioch Muirhead Kinloss Forres IV36 2UA
Customer	Mr PS McClue & Mrs K McClue
Date of Inspection	01/10/2024
Prepared by	India Hill Harvey Donaldson & Gibson Chartered Surveyors

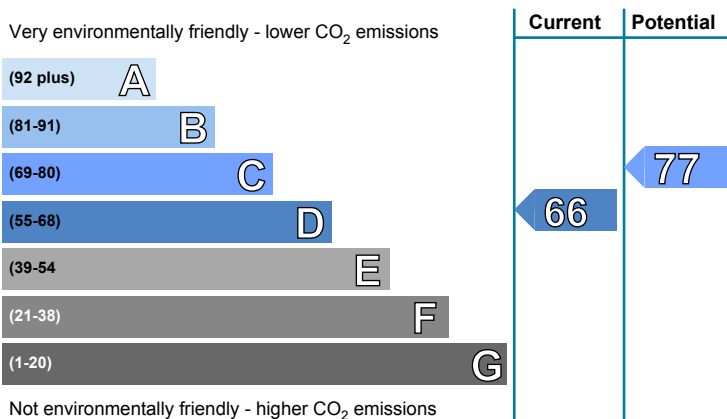
Environmental Impact (CO₂) Rating

This graph shows the effect of your home on the environment in terms of carbon dioxide (CO₂) emissions. The higher the rating, the less impact it has on the environment.
