HOME
report

SINGLE SURVEY
ENERGY REPORT
PROPERTY QUESTIONNAIRE
VALUATION REPORT

Survey report on:

Property Address	Newmill Cottage . Alves Forres IV36 2RB
Customer	Mrs A Wilson; Mrs A Scott & Mrs A Stewart
Date of Inspection	21/08/2024
Prepared by	Donna Shields Harvey Donaldson & Gibson Chartered Surveyors

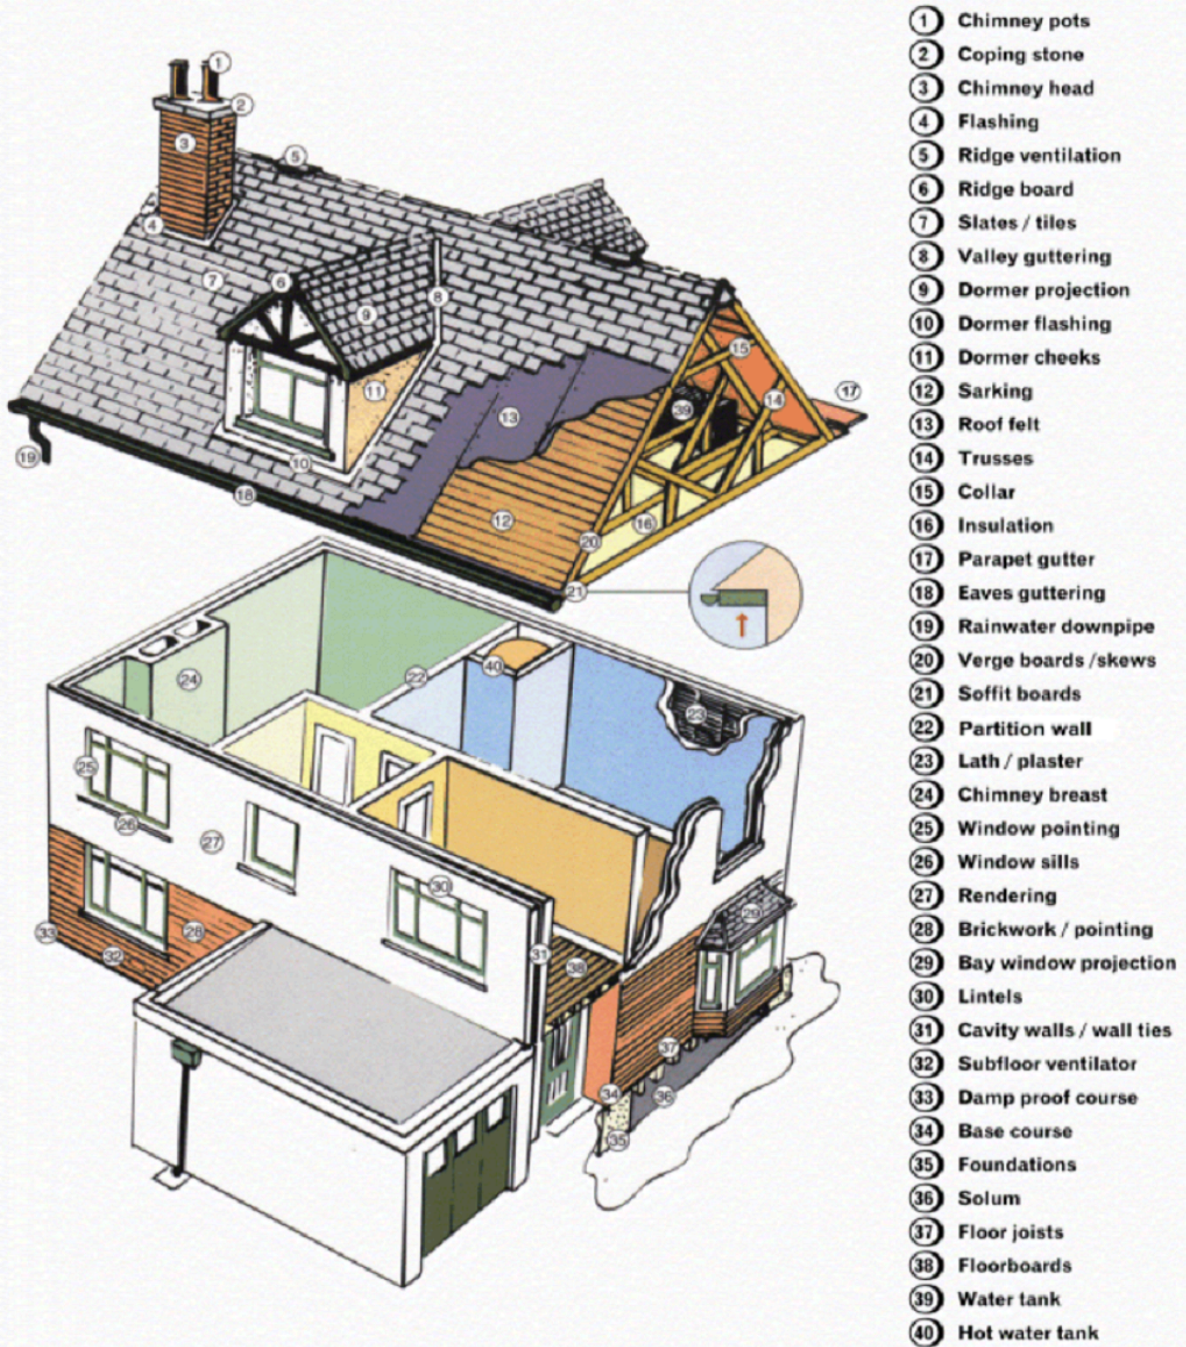
Sectional Diagram showing elements of a typical house

Reference may be made in this report to some or all of the above component parts of the property. This diagram may assist you in locating and understanding these items.

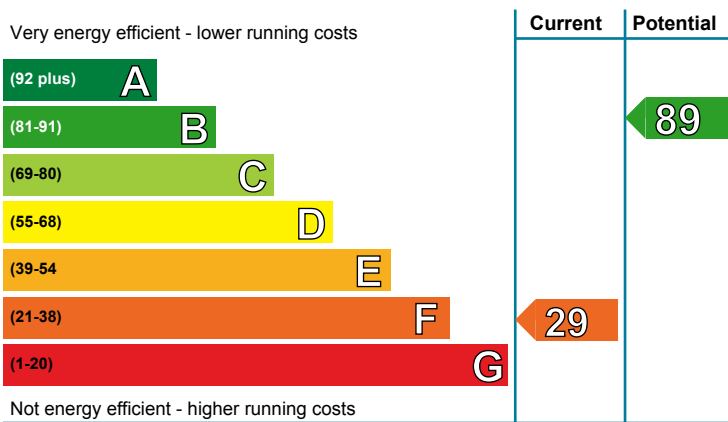
Energy Efficiency Rating

This graph shows the current efficiency of your home, taking into account both energy efficiency and fuel costs. The higher this rating, the lower your fuel bills are likely to be.

Your current rating is **band F (29)**. The average rating for EPCs in Scotland is **band D (61)**.

The potential rating shows the effect of undertaking all of the improvement measures listed within your recommendations report.
