**HOME**  
report

# Single Survey

<b>Property Address</b>	14 Park Street Burghead Elgin IV30 5UG
<b>Customer</b>	Mr S Mckenna & Ms S Laird
<b>Date of Inspection</b>	10/09/2024
<b>Prepared by</b>	India Hill Harvey Donaldson & Gibson Chartered Surveyors

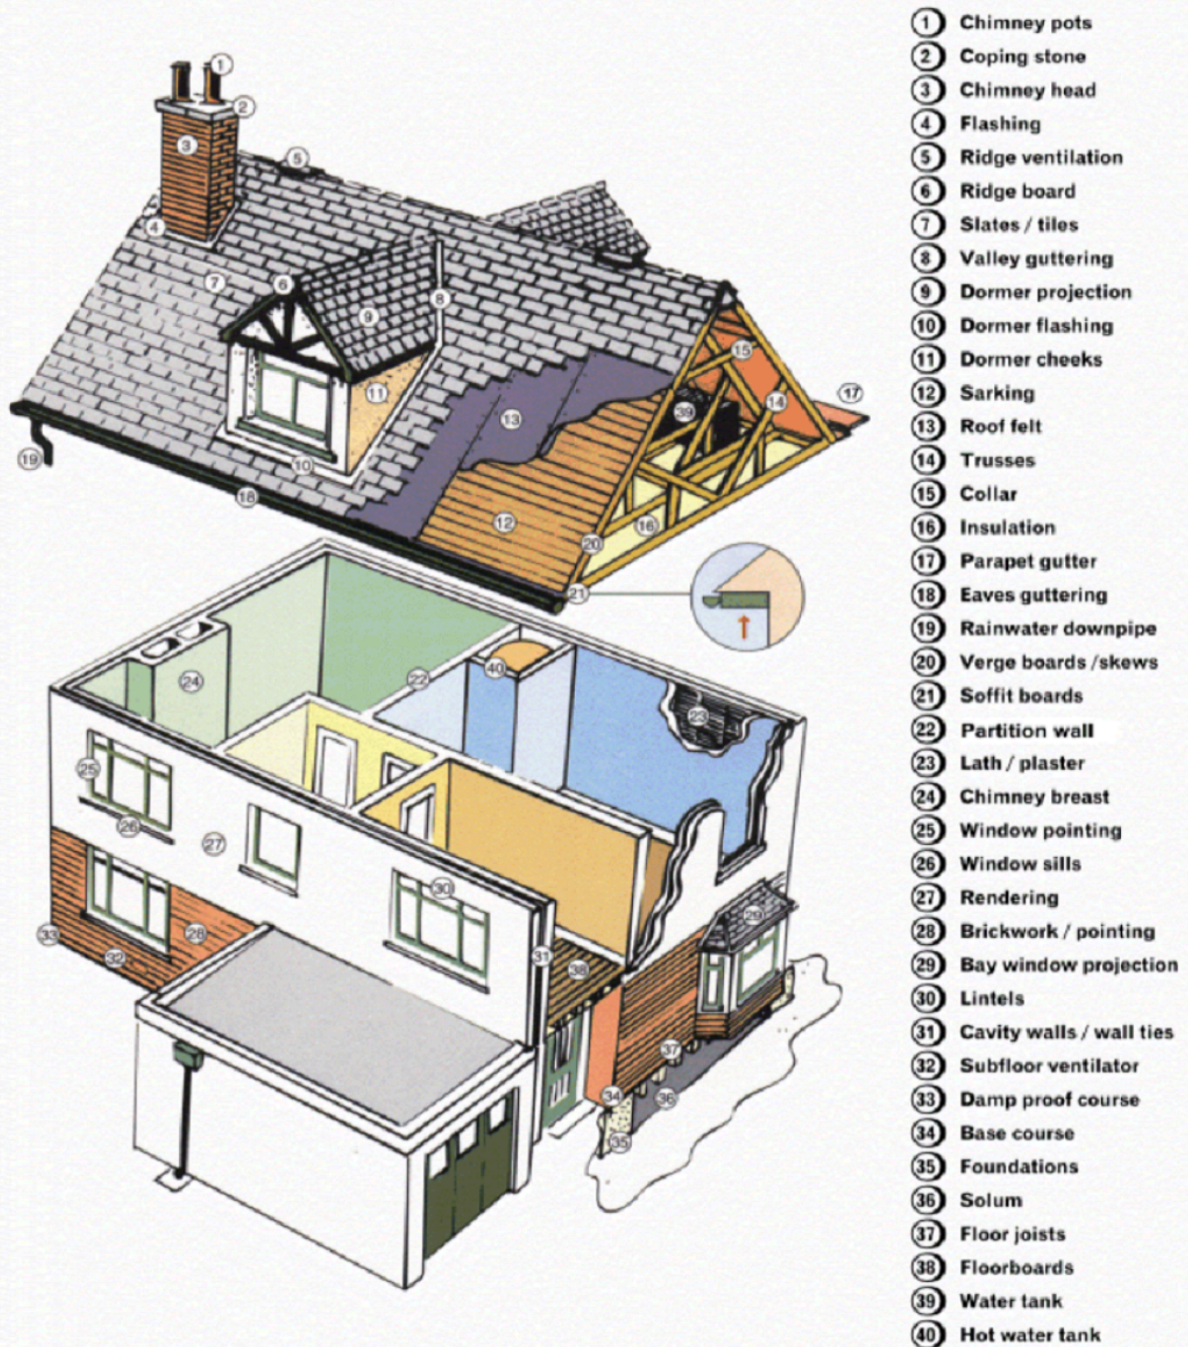
## Sectional Diagram showing elements of a typical house

Reference may be made in this report to some or all of the above component parts of the property. This diagram may assist you in locating and understanding these items.

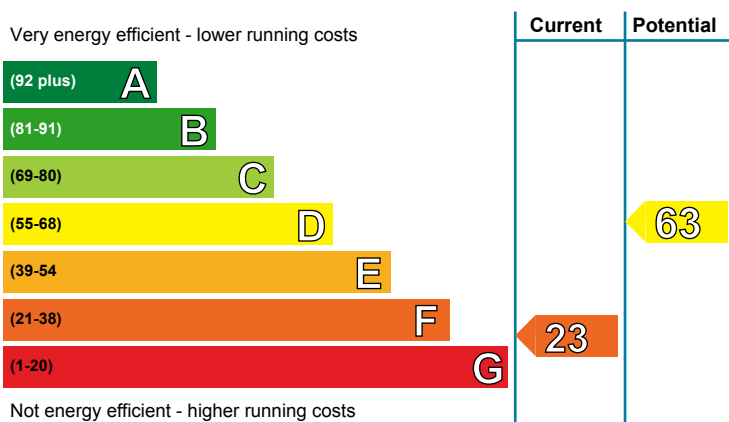
## Energy Efficiency Rating

This graph shows the current efficiency of your home, taking into account both energy efficiency and fuel costs. The higher this rating, the lower your fuel bills are likely to be.

Your current rating is **band F (23)**. The average rating for EPCs in Scotland is **band D (61)**.

The potential rating shows the effect of undertaking all of the improvement measures listed within your recommendations report.
