**HOME**  
report

SINGLE SURVEY  
ENERGY REPORT  
PROPERTY QUESTIONNAIRE  
VALUATION REPORT

# Single Survey

<b>Property Address</b>	19 Robertson Way Spey Bay Fochabers IV32 7PZ
<b>Customer</b>	Ms S Burns (POA) & Ms H Mills
<b>Date of Inspection</b>	11/07/2024
<b>Prepared by</b>	Donna Shields Harvey Donaldson & Gibson Chartered Surveyors

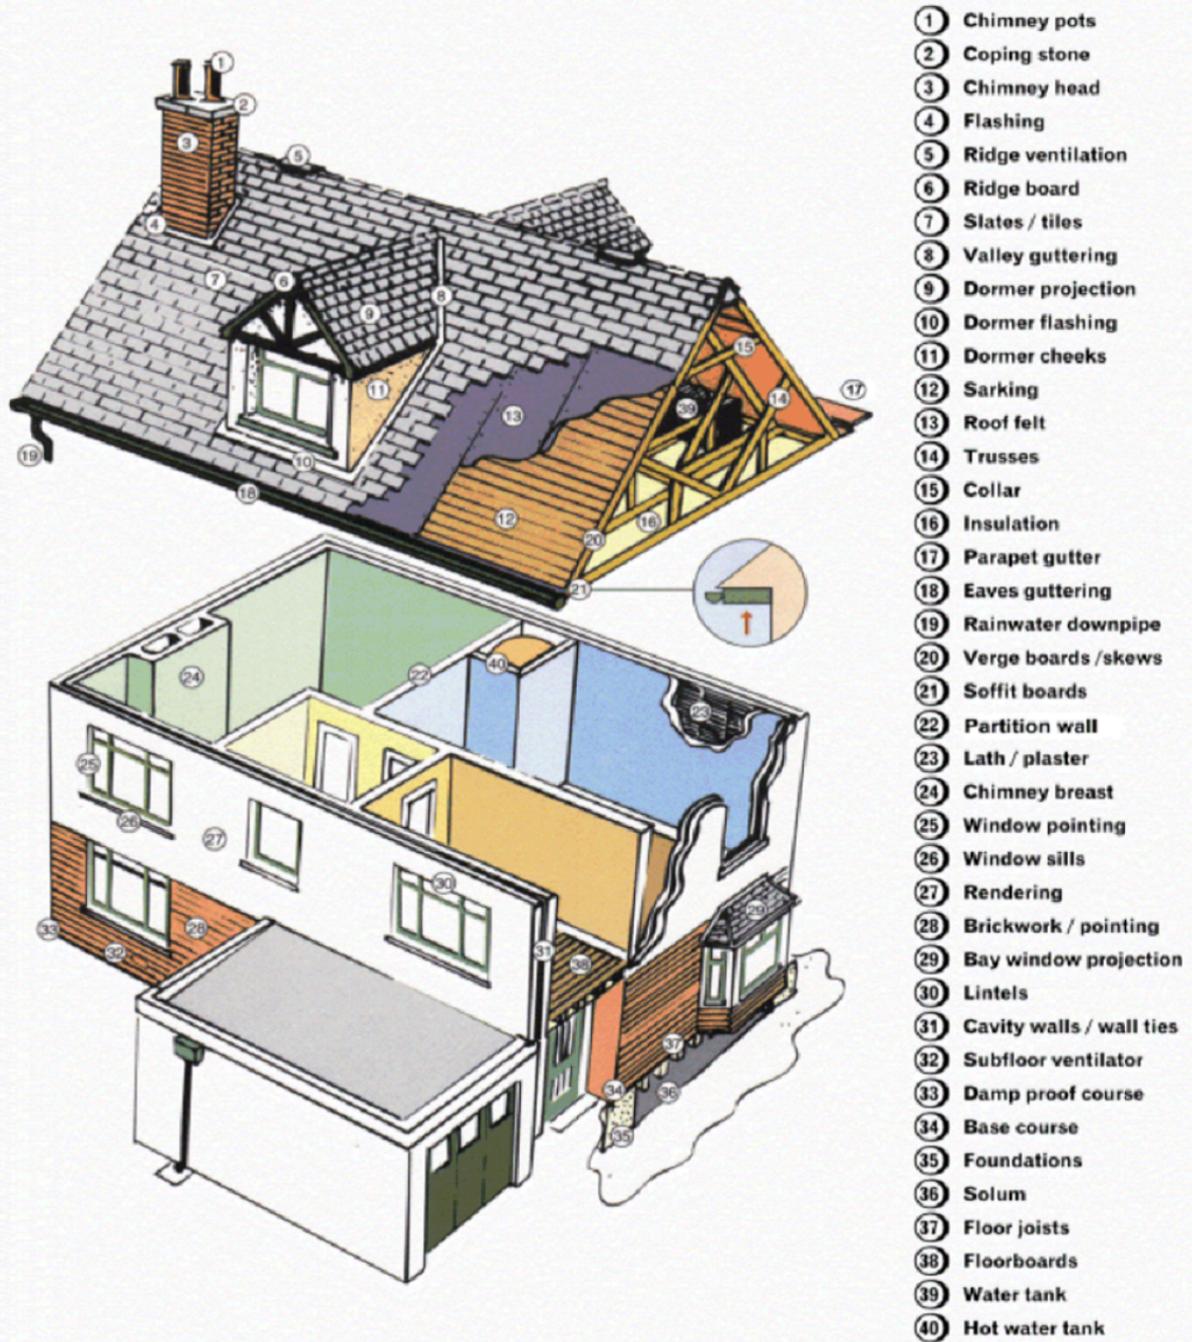
## Sectional Diagram showing elements of a typical house

Reference may be made in this report to some or all of the above component parts of the property. This diagram may assist you in locating and understanding these items.

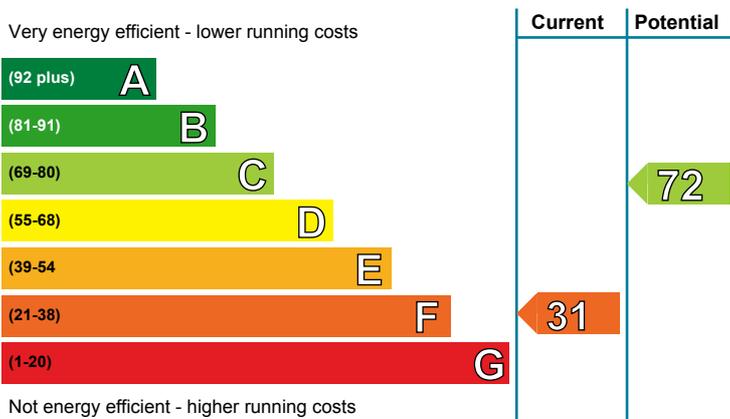
## Energy Efficiency Rating

This graph shows the current efficiency of your home, taking into account both energy efficiency and fuel costs. The higher this rating, the lower your fuel bills are likely to be.

Your current rating is **band F (31)**. The average rating for EPCs in Scotland is **band D (61)**.

The potential rating shows the effect of undertaking all of the improvement measures listed within your recommendations report.

<b>Estimated energy costs for your home for 3 years*</b>	<b>£6,675</b>	See your recommendations report for more information
<b>Over 3 years you could save*</b>	<b>£3,114</b>

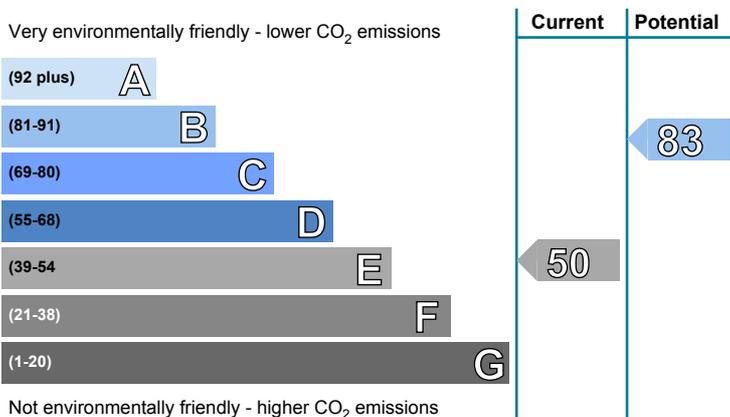
## Environmental Impact (CO<sub>2</sub>) Rating

This graph shows the effect of your home on the environment in terms of carbon dioxide (CO<sub>2</sub>) emissions. The higher the rating, the less impact it has on the environment.
