CRAIGHURST SEAFIELD AVENUE

Home Report

CRAIGHURST, SEAFIELD AVENUE, KEITH, AB55 5BS

Scottish Single Survey

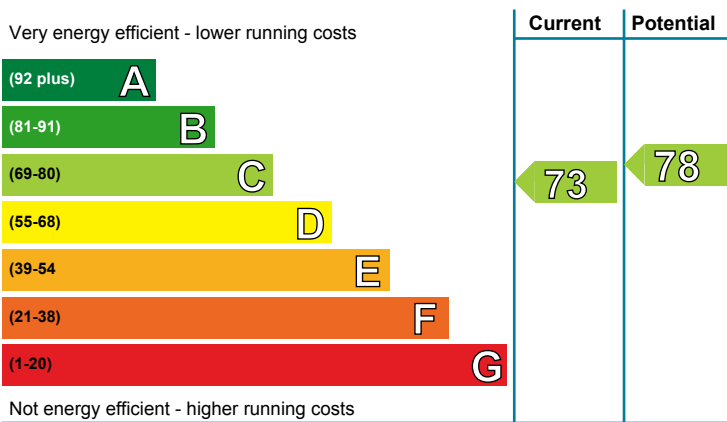
Energy Efficiency Rating

This graph shows the current efficiency of your home, taking into account both energy efficiency and fuel costs. The higher this rating, the lower your fuel bills are likely to be.

Your current rating is **band C (73)**. The average rating for EPCs in Scotland is **band D (61)**.

The potential rating shows the effect of undertaking all of the improvement measures listed within your recommendations report.

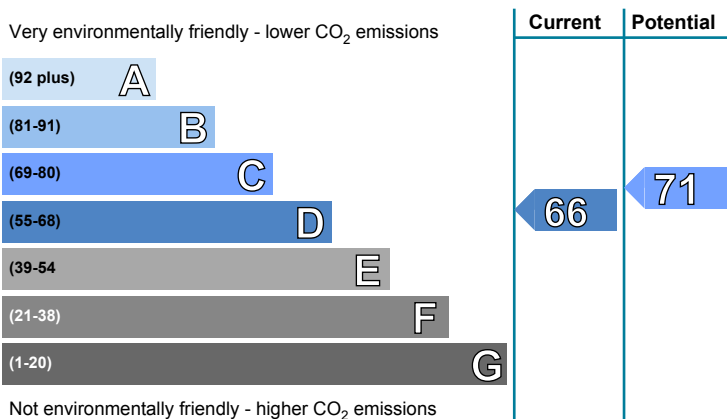
Environmental Impact (CO₂) Rating

This graph shows the effect of your home on the environment in terms of carbon dioxide (CO₂) emissions. The higher the rating, the less impact it has on the environment.

Your current rating is **band D (66)**. The average rating for EPCs in Scotland is **band D (59)**.

The potential rating shows the effect of undertaking all of the improvement measures listed within your recommendations report.
